FINAL REPORT
TO
NOVA SCOTIA DEPARTMENT OF TRANSPORTATION AND PUBLIC WORKS
ON
ENVIRONMENTAL ASSESSMENT

783 CENTRAL AVENUE, GREENWOOD, NOVA SCOTIA

SUBMITTED
BY
PINCHIN LEBLANC ENVIRONMENTAL LIMITED
PLEL PROJECT #01-5372

AUGUST, 2005

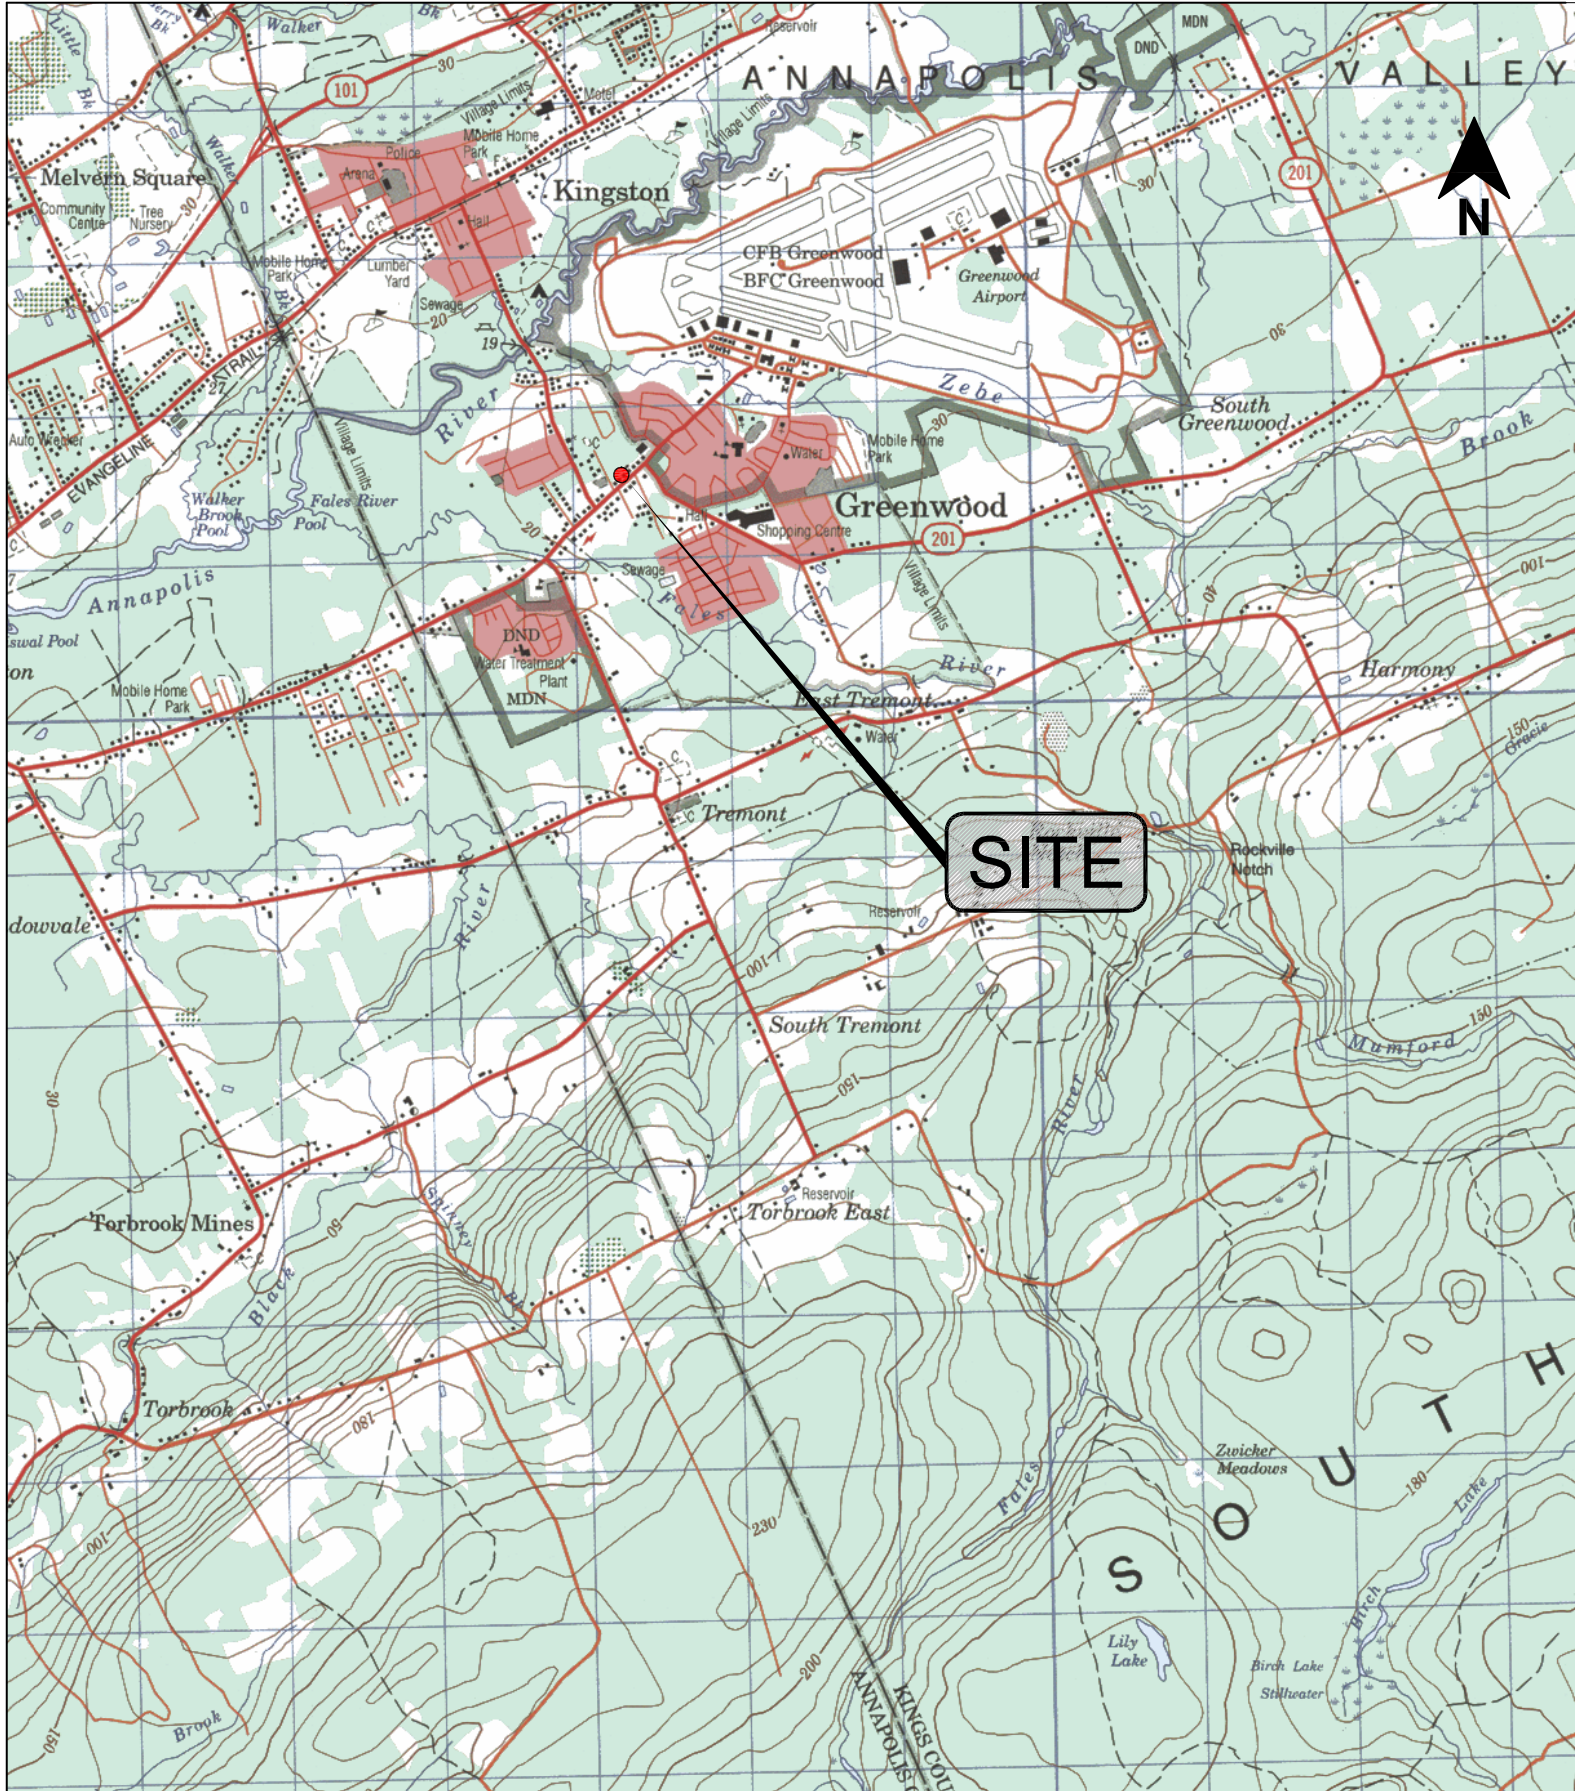
DATE: JULY 2005	PROJECT # 01 - 5372	SCALE: 1 : 50,000	DRAWN BY: D. CHAISSON	CHECKED BY: C. DICKSON	FIGURE NO. 1
--------------------	------------------------	----------------------	--------------------------	---------------------------	-----------------

The site is located at 783 Central Avenue (Route 201) in Greenwood, Nova Scotia (Figure 1). Service Nova Scotia and Municipal Relations (SNSMR) lists the PID of the property as 55120372 and the current owner as Everett and Smith Ltd. The site is located on the north side of Central Ave. about 250 metres northeast of the intersection with Bridge Street.

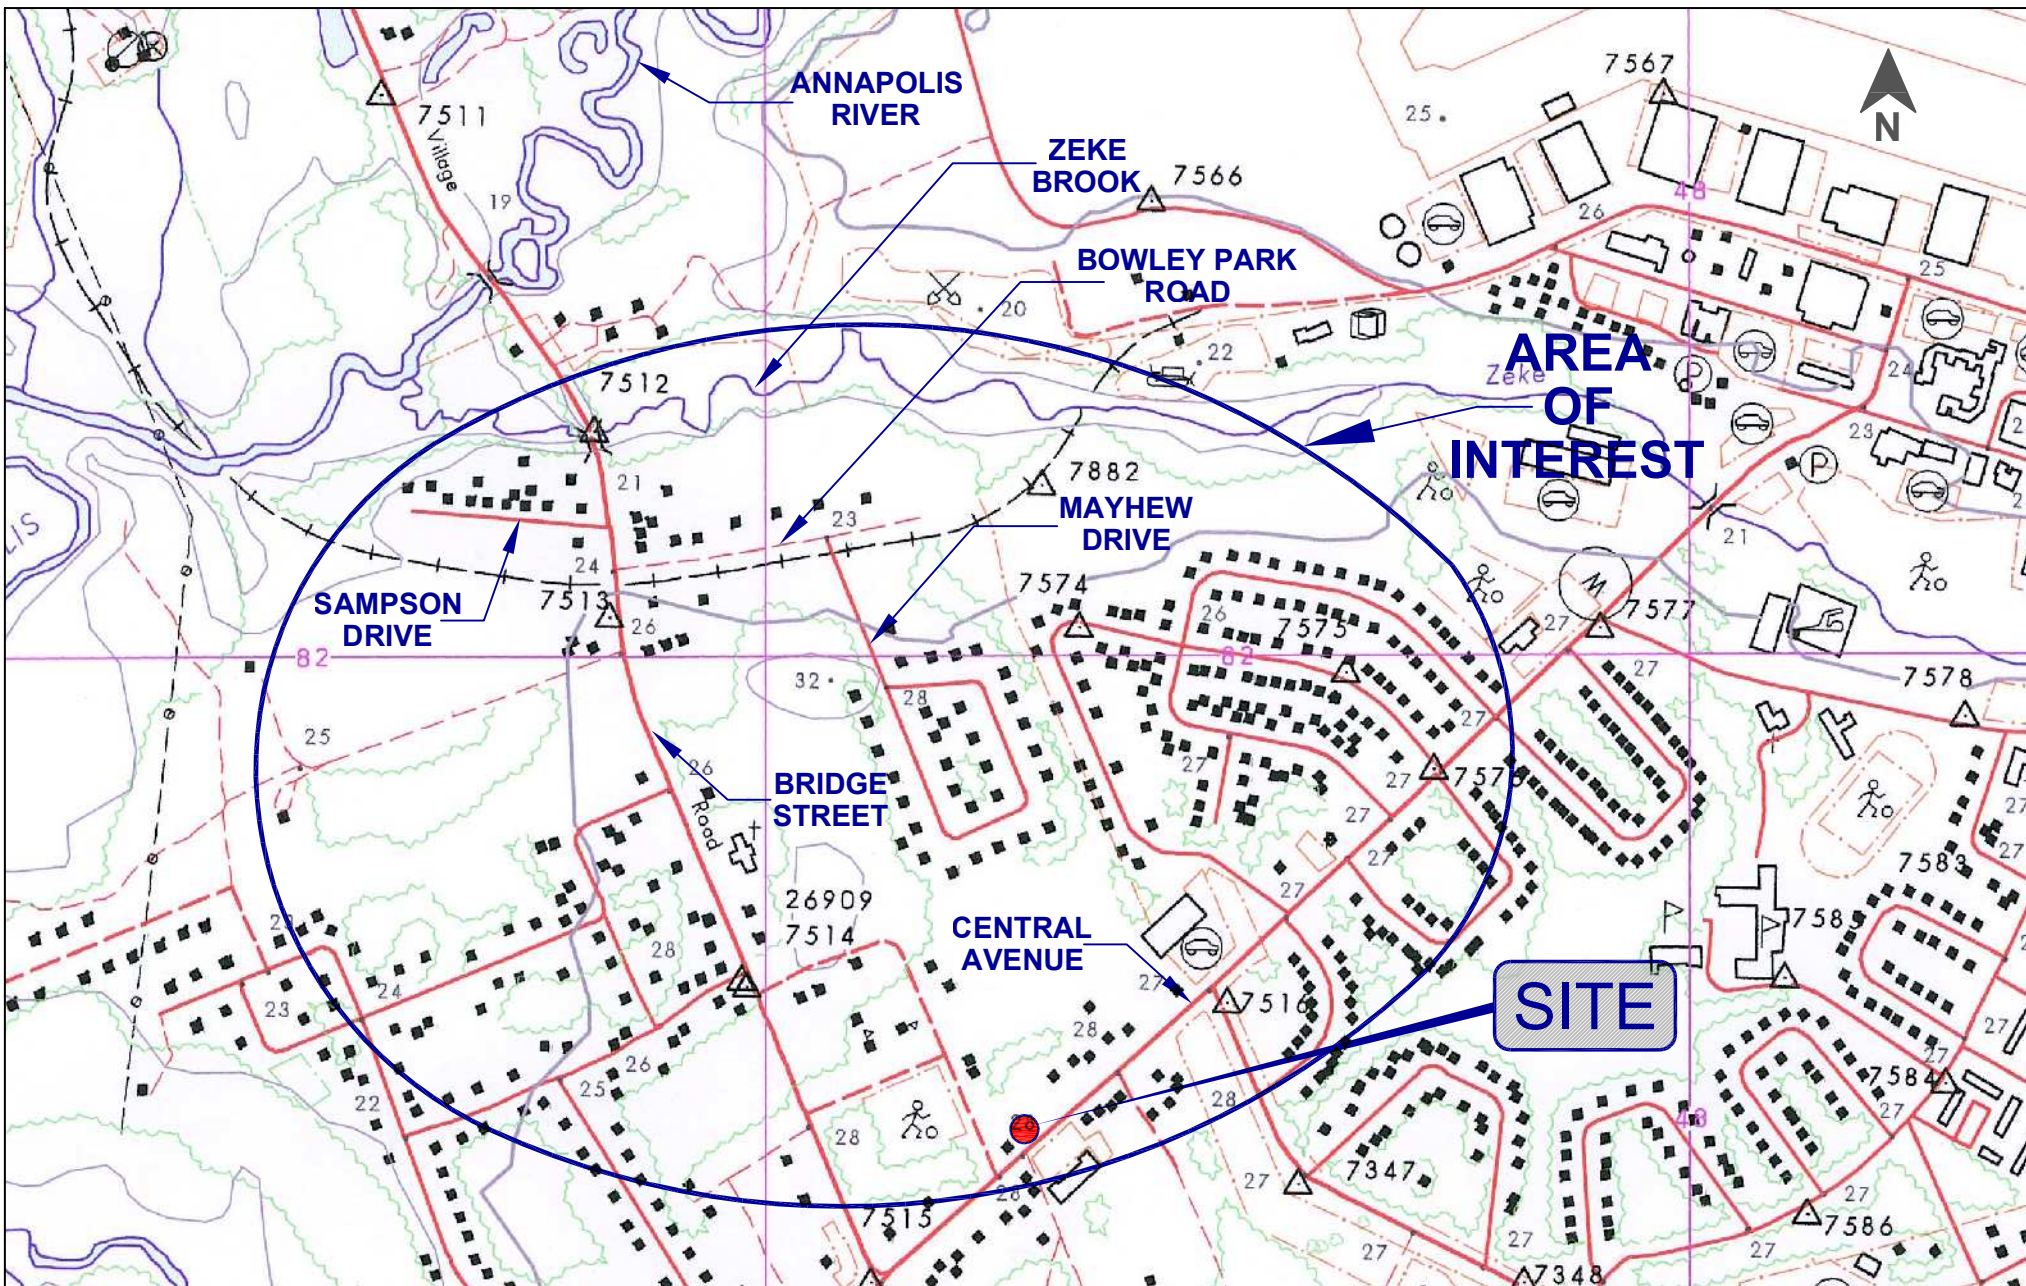
DATE: JULY 2005	FIGURE: 2
PROJECT NO: 01 - 5372	SCALE: N. T. S.
DRAWN BY: D. CHAISSON	CHECKED BY: C. DICKSON
SOURCE: 1 : 10,000 MAP SHEET 1044 9500 64 900

NOVA SCOTIA DEPARTMENT OF TRANSPORTATION & PUBLIC WORKS
 ENVIRONMENTAL SITE ASSESSMENT
 783 CENTRAL AVENUE, GREENWOOD, NOVA SCOTIA
AREA OF INTEREST

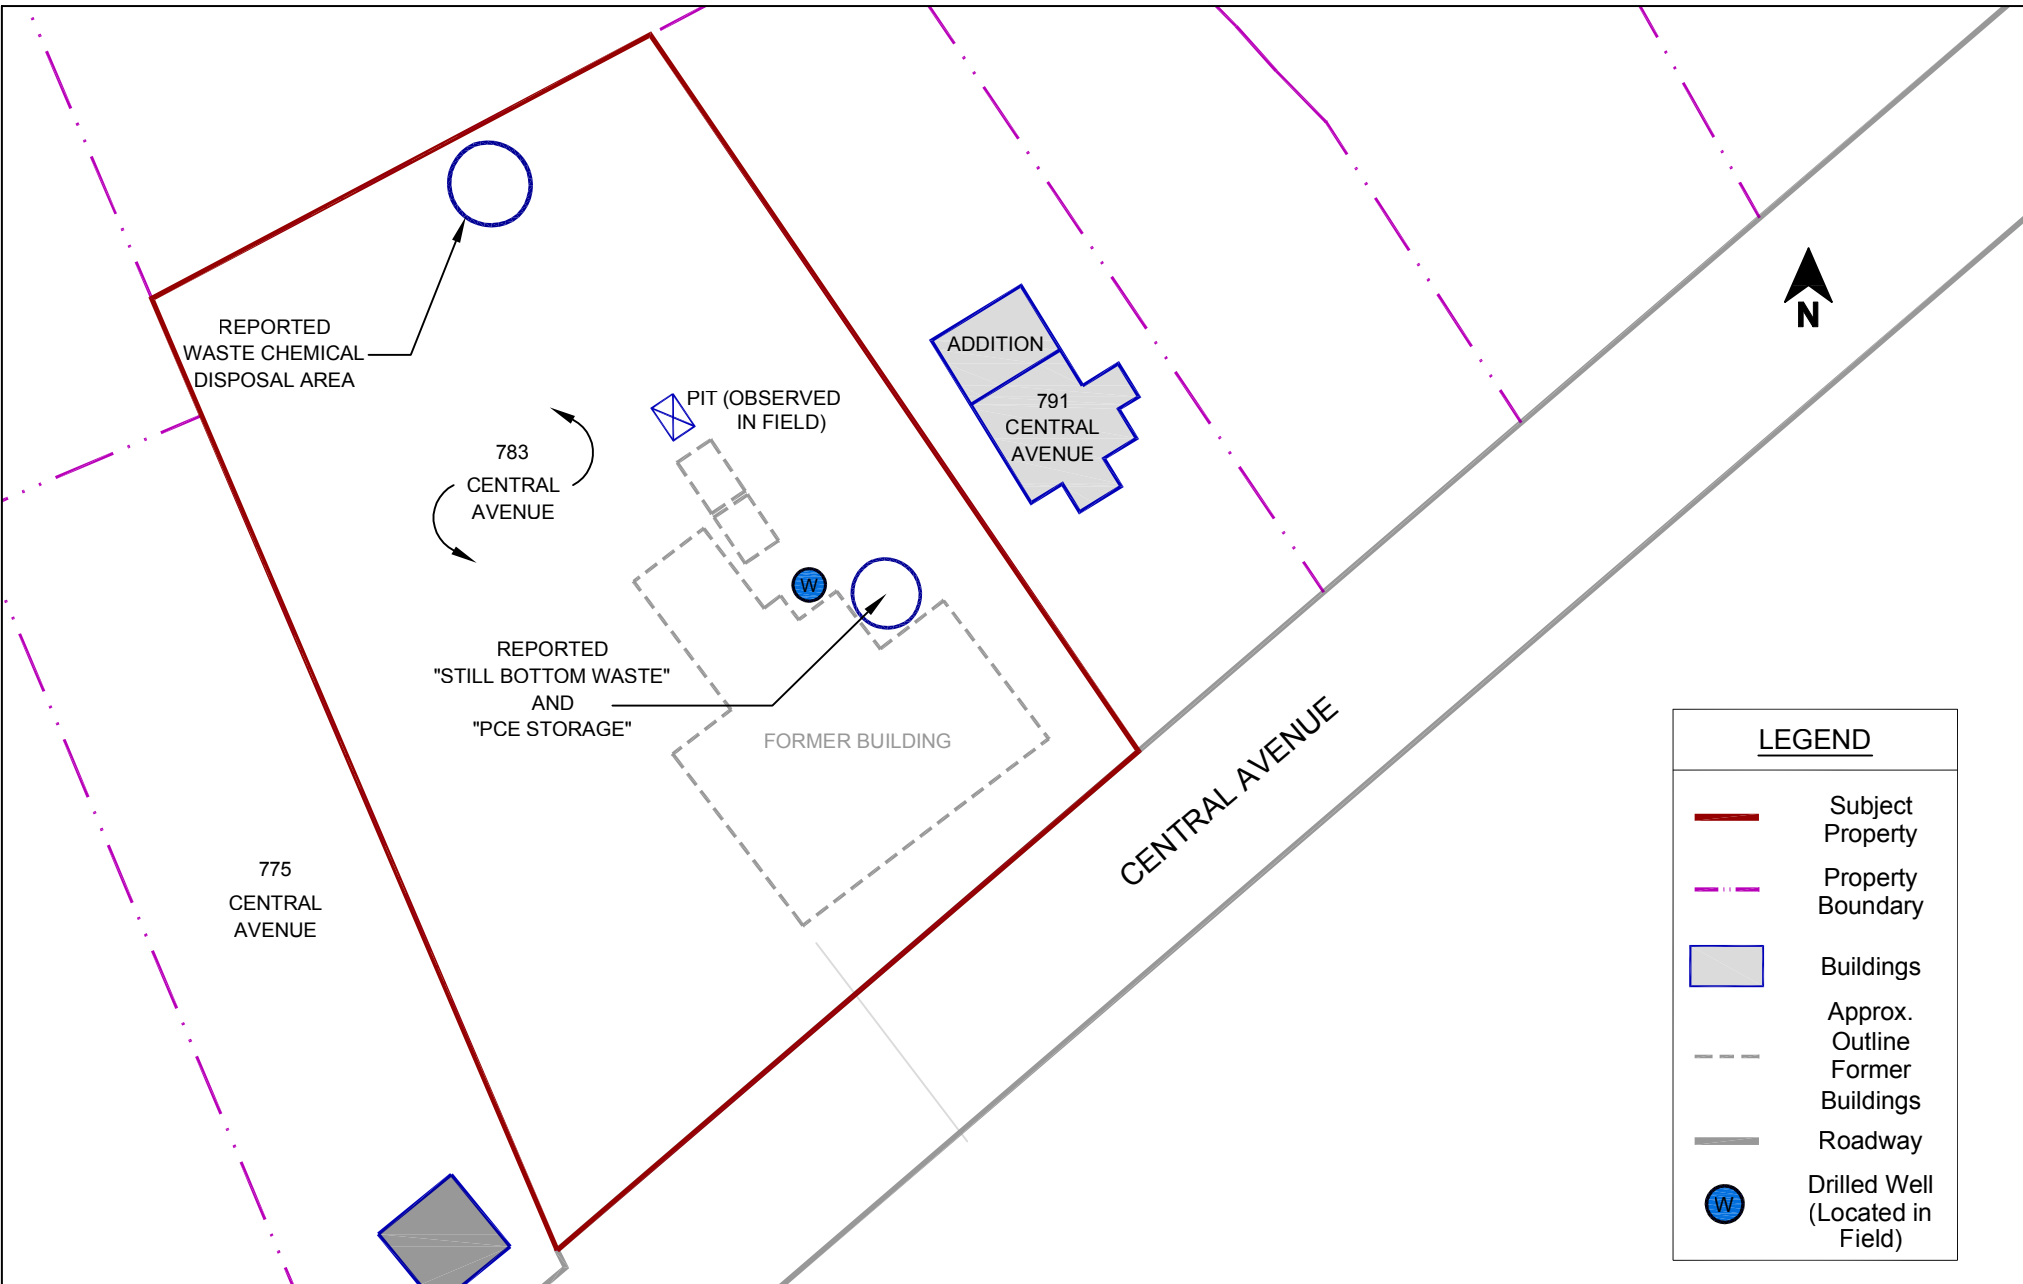
DATE: JULY 2005	FIGURE: 3
PROJECT NO: 01 - 5372	SCALE: N. T. S.
DRAWN BY: D. CHAISSON	CHECKED BY: C. DICKSON
SOURCE: NOVA SCOTIA PROPERTY RECORDS

NOVA SCOTIA DEPARTMENT OF TRANSPORTATION & PUBLIC WORKS
 ENVIRONMENTAL SITE ASSESSMENT
 783 CENTRAL AVENUE, GREENWOOD, NOVA SCOTIA
SITE PLAN

The outline of the building which once occupied the site is shown on Figure 3. A drilled well was located just off the east side of the structure. Historical records supplied as part of this assessment included sketches which indicate “Still Bottom Waste Storage in Barrels” and “PCE Storage” in the same general area. There are anecdotal reports that waste chemicals were discarded on the ground surface at the treeline behind the former building (Figure 3).

In the past, the site used a 150 mm diameter drilled well as a water supply. The location of the well, drilled in 1969 and located during this study, is shown on Figure 3. It is reported that this well was 37.2 metres (122') deep and that bedrock was encountered at 18.6 m (61'). Approximately 20 metres (66') of casing was installed in the well. There are other reports of a sandpoint-type well located adjacent to the drilled well. It is presumed that this sandpoint predates the drilled well but, in any event, there is no remaining evidence of the installation.

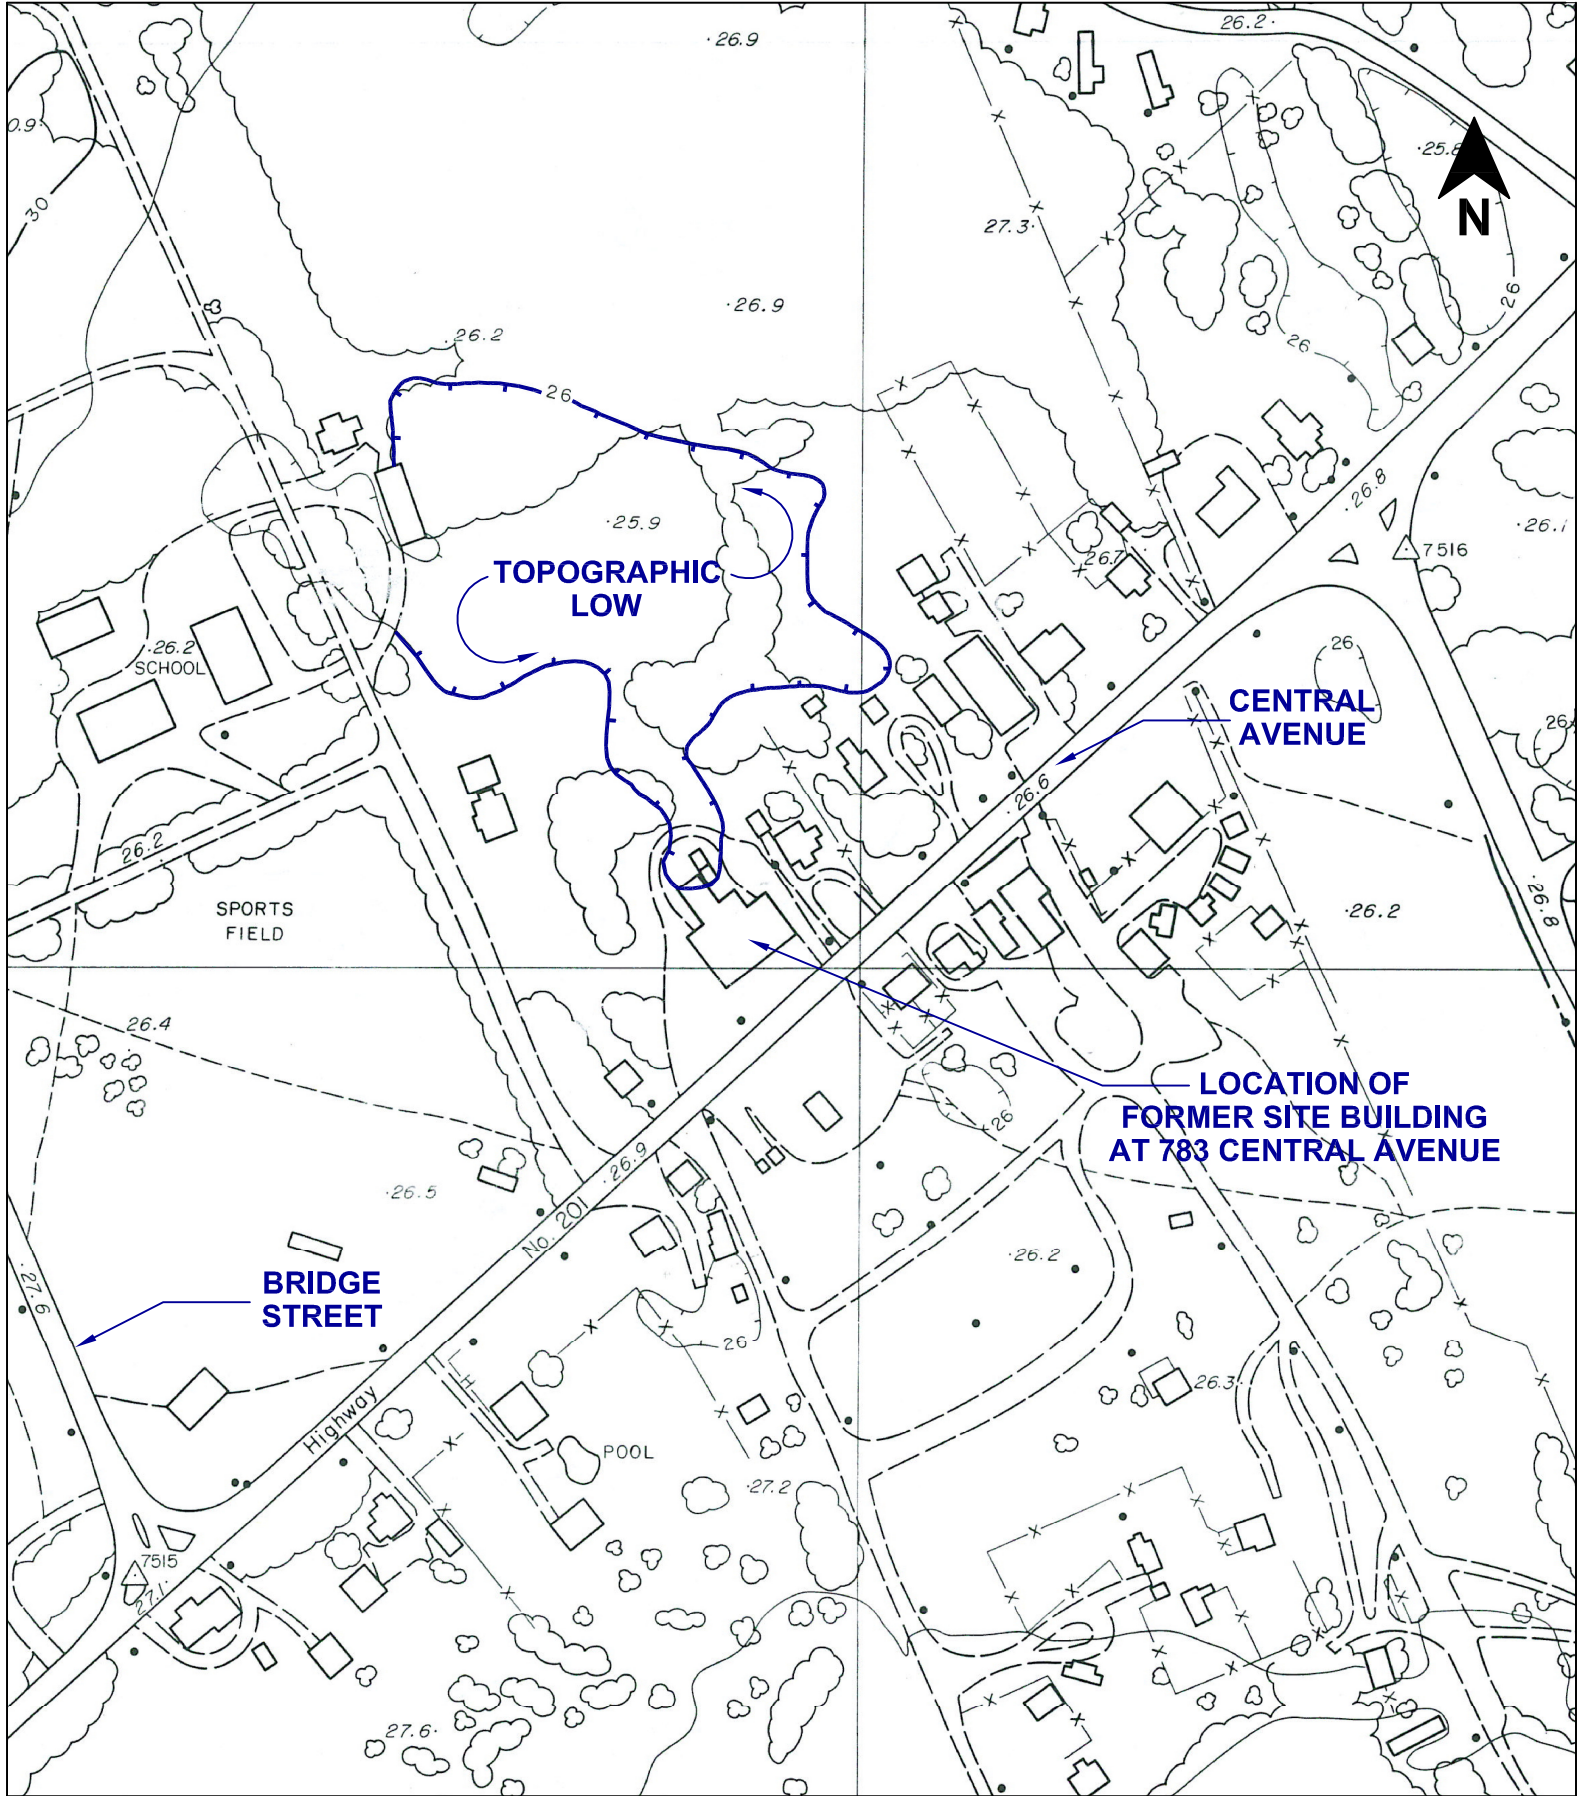
DATE: JULY 2005	PROJECT # 01 - 5372	SCALE: 1 : 2400	DRAWN BY: D. CHAISSON	CHECKED BY: C. DICKSON	FIGURE NO. 4
--------------------	------------------------	--------------------	--------------------------	---------------------------	-----------------

The site lies at an elevation of about 26 metres above sea level in a flat to gently rolling valley lowland setting. The site itself is level and well-drained. The surrounding area is also relatively level with general drainage directions towards Zeke Brook and the Annapolis River to the north and northwest. There are no brooks, streams or bodies of standing water in the general area of the site. However, there is a slight topographic low area immediately to the north and northwest of the site (Figure 4). This low area would collect surface drainage from several directions including from the site itself.

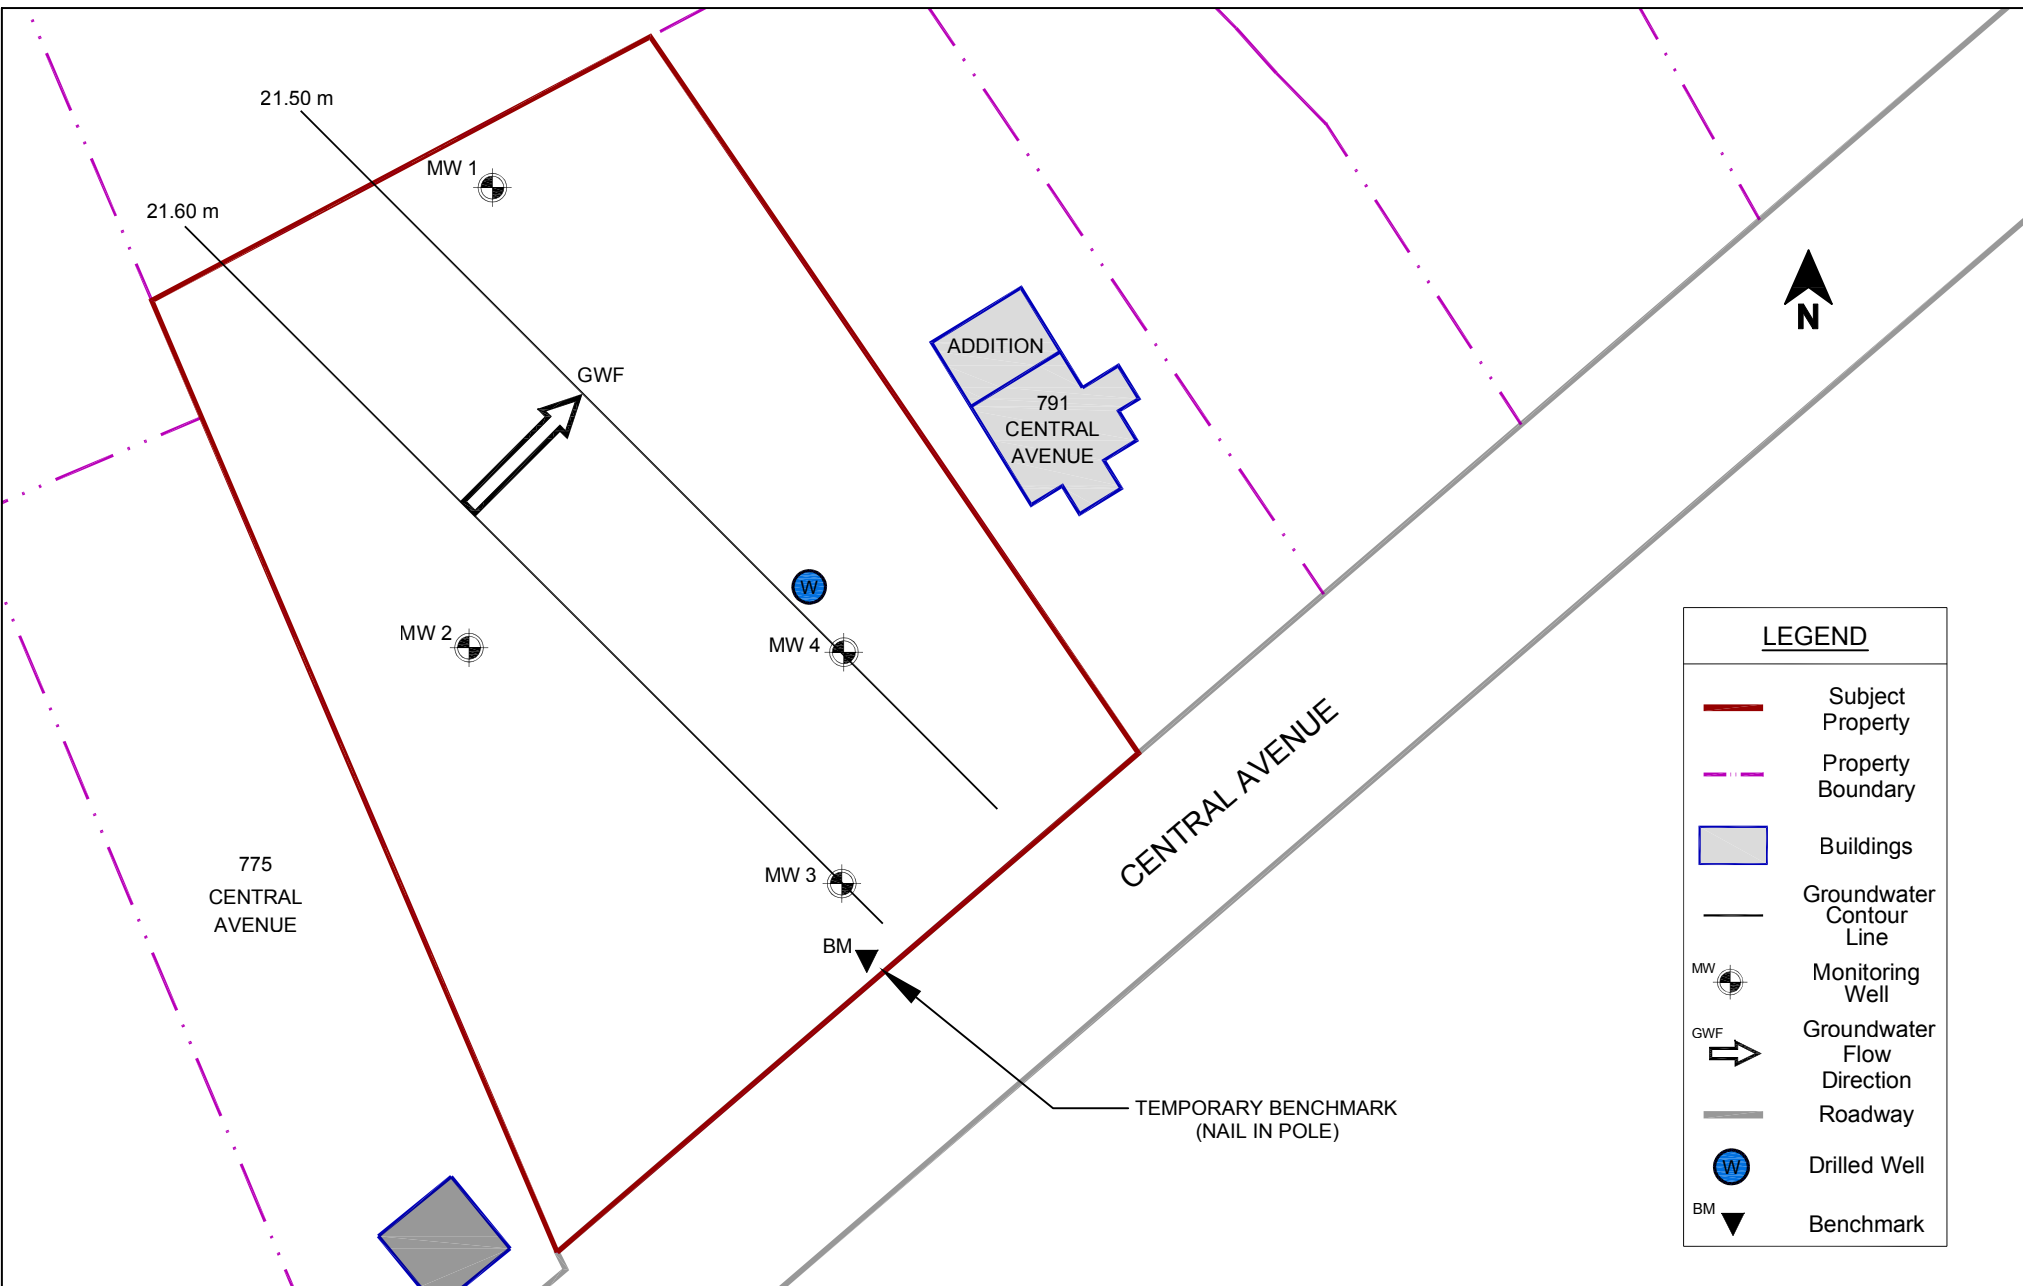
DATE: JULY 2005	FIGURE: 5
PROJECT NO: 01 - 5372	SCALE: N. T. S.
DRAWN BY: D. CHAISSON	CHECKED BY: C. DICKSON
SOURCE: NOVA SCOTIA PROPERTY RECORDS

NOVA SCOTIA DEPARTMENT OF TRANSPORTATION & PUBLIC WORKS
 ENVIRONMENTAL SITE ASSESSMENT
 783 CENTRAL AVENUE, GREENWOOD, NOVA SCOTIA
 BOREHOLE / MONITOR WELL LOCATIONS
 & GROUNDWATER FLOW DETAILS

Borehole locations are shown on Figure 5.

Monitor well locations are shown on Figure 5. Well construction details are provided on the Monitor Well Logs in Appendix B.

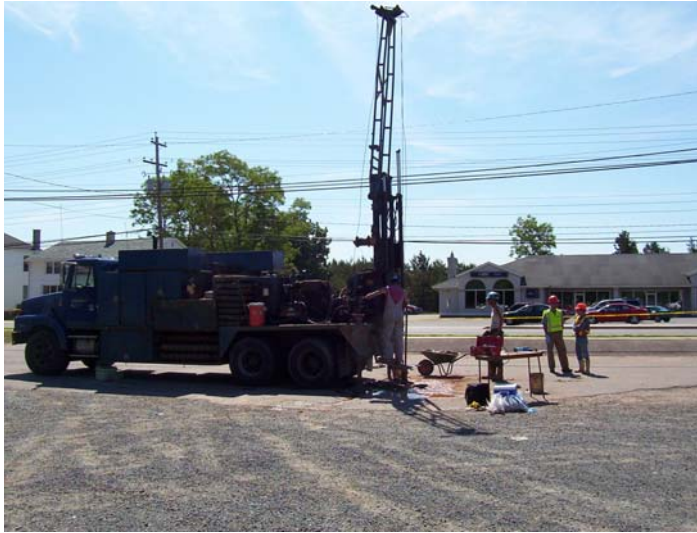
Photo 5: Drilling of MW 3 at south end of property.

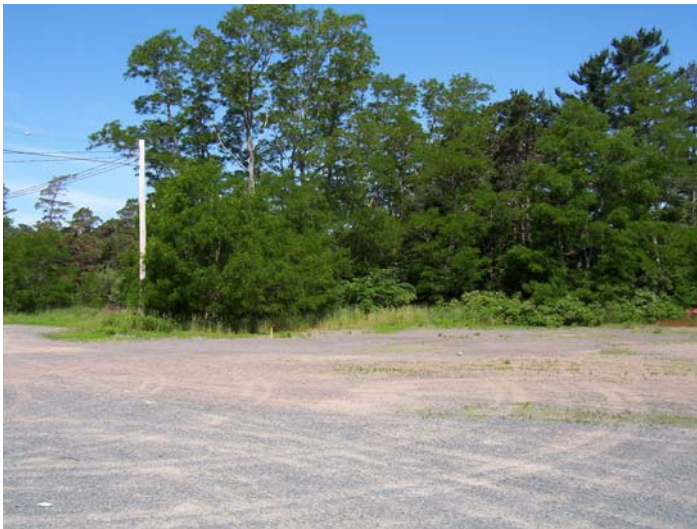
Photo 6: Northwest view of property and location of monitor well MW 2.

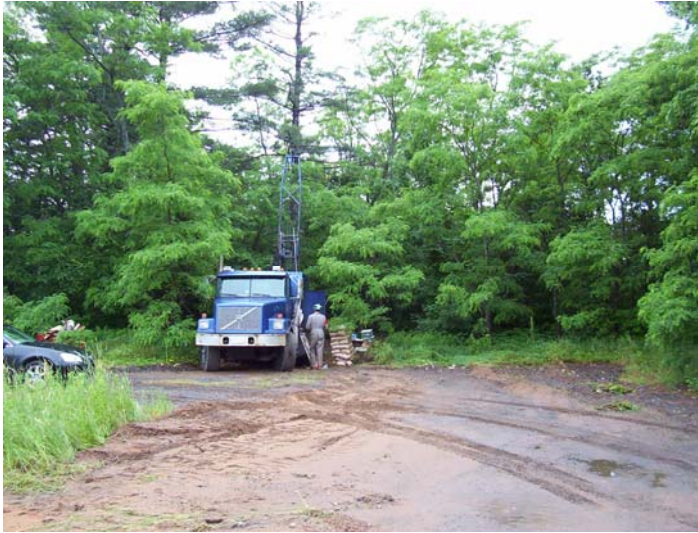
Photo 7: Drilling of MW 1 at north end of property.

The boreholes were drilled during the period July 5-7, 2005 by Lantech Drilling Services Inc. using a truck-mounted CME 55 auger rig. Borehole MW 1 was located in an area suspected to be a site where waste chemicals were discarded on the ground surface behind the former dry cleaning operation. MW 2 was placed to investigate conditions on the western fringe of the site. MW 3 was situated to investigate conditions “up-gradient” from the former dry cleaning operations. MW 4 investigated an area that may have been the general location of a former underground tank and/or what has been referred to as a “Still Bottom Waste” storage area.

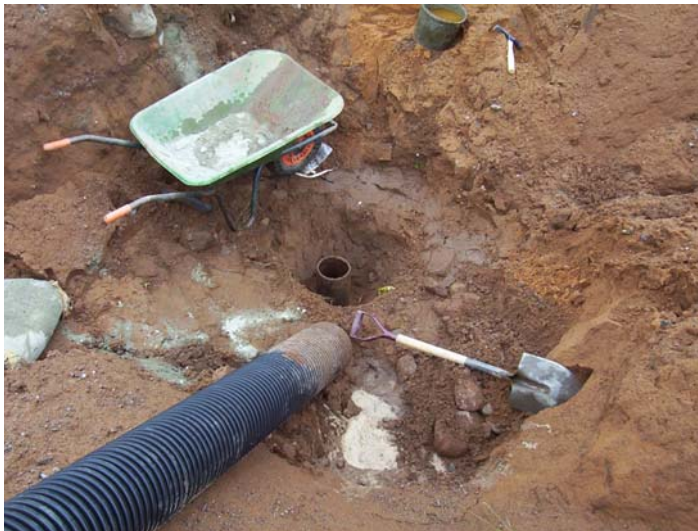
Photo 8: Drilled well casing exposed during excavation operations.

It was known that a drilled well was once present on the property. Initial attempts to locate the well with hand-held metal detector were unsuccessful and a rubber-tired backhoe was used to excavate in the suspected well location area. This work was conducted on July 6, 2005. The excavation work led to the discovery of a copper water line that apparently had run from the main building to an outbuilding at the rear of the site (see photographs, Appendix D). The well was located and uncovered. The pump that was once connected to the well was found buried near the well. The top of the steel well casing was covered with a conventional well seal and the depth to the top of the well casing was approximately 1.5 m below ground surface. A 200 mm diameter corrugated PVC riser with a locking lid was fabricated and placed over the well casing. The joint between the riser and the steel casing was cemented with quick-set grout. The well was then backfilled using the previously-excavated soils.

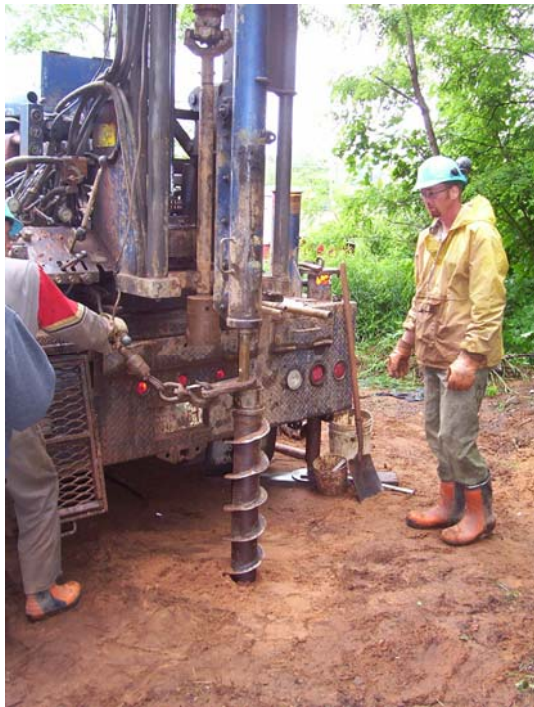
Photo 9: Drilling of MW 1 with hollow stem auger.

The boreholes were drilled using 200 mm hollow stem augers to depths ranging from 9.1 m (MW 4) to 18.3 m (MW 1). Soils were sampled continuously to a depth of about 4 to 5 m and at 1.5 metre intervals below that depth using split spoon samplers. In general, it was not possible to sample soils with split spoon apparatus below a depth of 8 to 12 m. This was due to severe “piping” of sand into the hollow stem augers. Auger samples were obtained at greater depths in the boreholes.

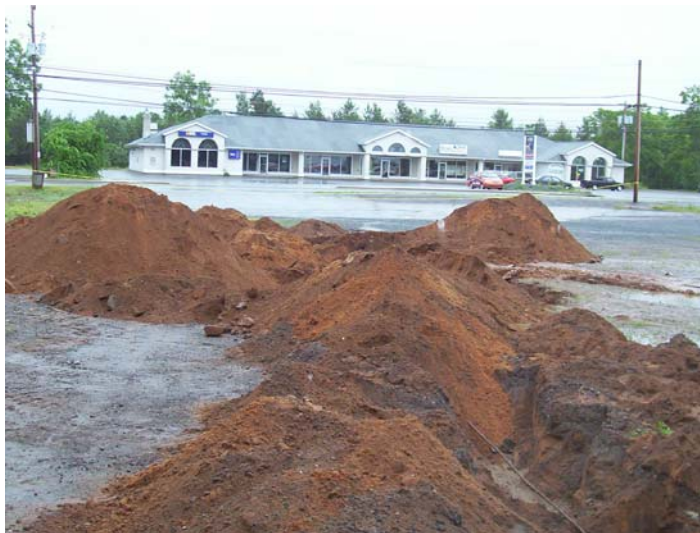
Photo 10: Extent of excavation area along eastern portion of property.

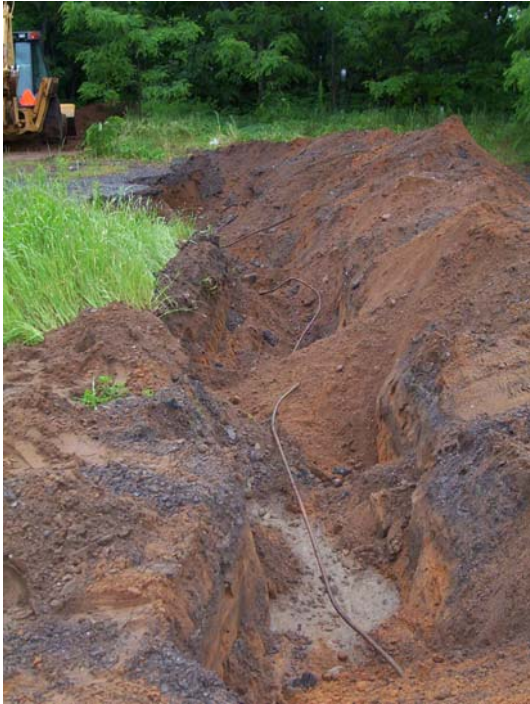
Photo 11: Water line discovered during excavation operations. The line extends to rear of property.
